# A CASE STUDY OF POST-EARTHQUAKE STRUCTURAL ENGINEERING – THE BALTIMORE BASILICA

Matthew J. Daw<sup>1</sup> and C.Swift<sup>2</sup>

The response, assessment, and recovery effort as undertaken by Keast & Hood Co. for the Archdiocese of Baltimore provides a case study for post-disaster preservation of historic structures including immediate response, temporary stabilization, and post-response repairs with visually subtle, yet structurally sound, restoration detailing.

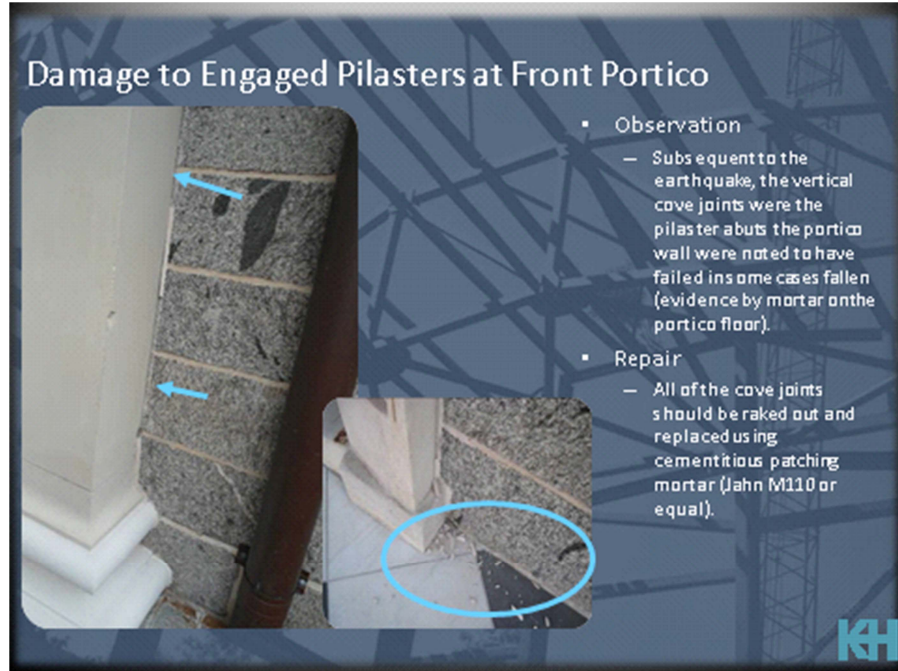
Figure 1. Damage to engaged pilasters at front portico.

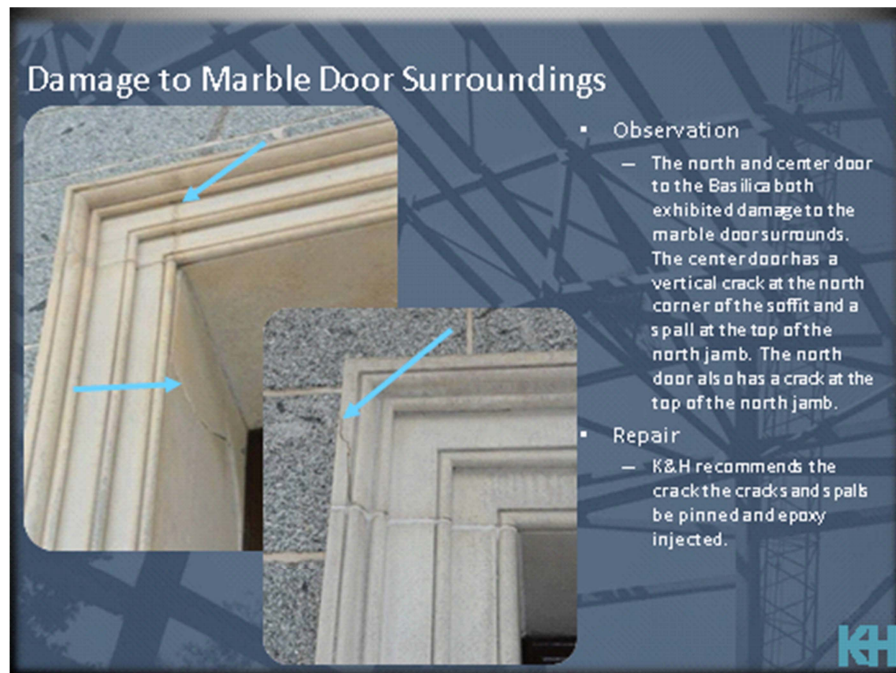
Figure 2. Damage to marble door surroundings.

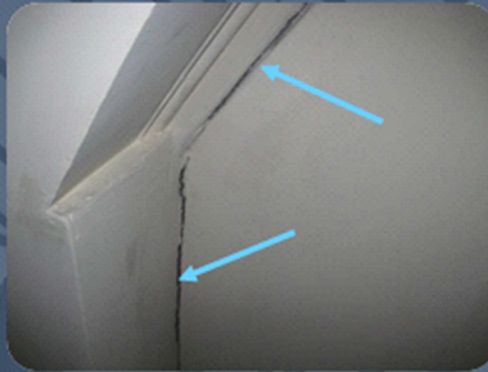
- Observation
  - In the main body of the church the connection of the westernmost barrel vault to the west wall opened up, creating a gap between the vault and the wall. This was a result of the much heavier west wall moving independently of the barrel vault.
- Repair
  - K&H recommended the plaster ceilings should be patched and repaired as necessary to close the gap between the wall and the vault. Reconnection of the barrel vault to the wall was not recommended.

Figure 3. Separation between barrel vault and west wall connection.

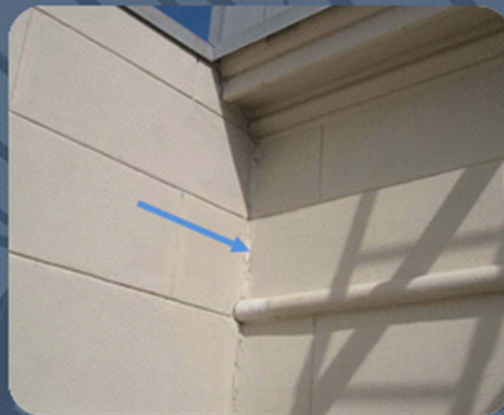
- Observation
  - At the roof level, the north tower connection to the west wall of the church was observed to have recently cracked. Cracking was clearly evident within the Keim coating on the masonry walls.
- Repair
  - K&H recommended patching in kind of the Keim coating in order to close the crack.

Figure 4. Distress at North Bell Tower to West Bell Tower connection.

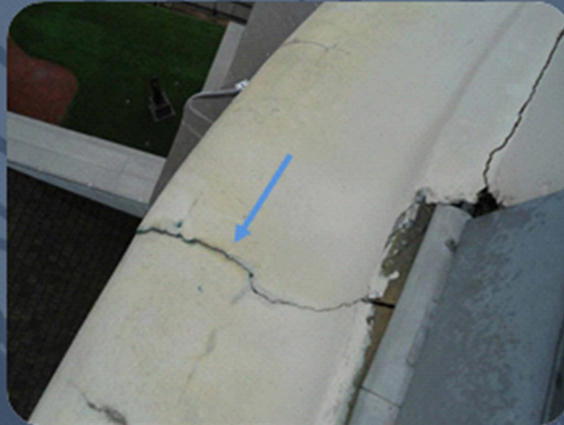
- Observation
  - The cornice level of both bell towers exhibited radial cracking. After sounding the material it was determined that the cornice is a parge coat cementitious on top of cladding. This thin coating was very loose in some locations and in danger of falling.
- Repair
  - K&H recommended the cementitious pargings should be removed and replaced.

Figure 5. Radial cracking at bell tower cornices.

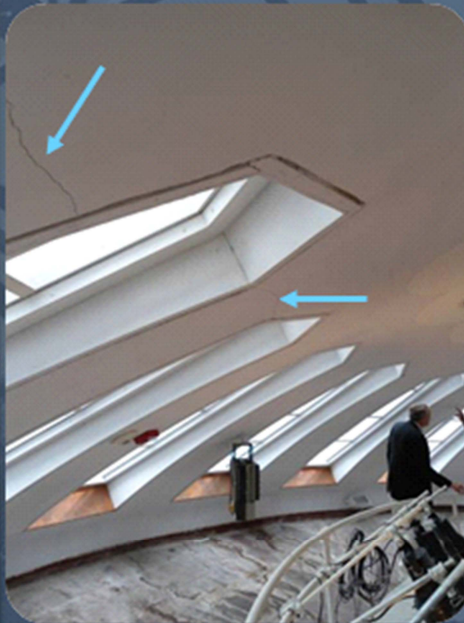
- Observation
  - Cracks were noted in the monitor above the main dome. Typically, the cracks traveled between the skylight window heads. However, there were two locations where the cracks were observed to extend below the window heads. The plaster was sounded in the vicinity of the cracks and did not appear to sound loose.
- Repair
  - K&H recommended the cracks should be chased out with removal of the plaster for observation of the structural backup. Cracks in the masonry structure were recommended to be injected with a low-viscosity cementitious mortar (Jan M30 #31 or M40, depending on the crack width, or equivalent).

Figure 6. Cracks in monitor above main dome.

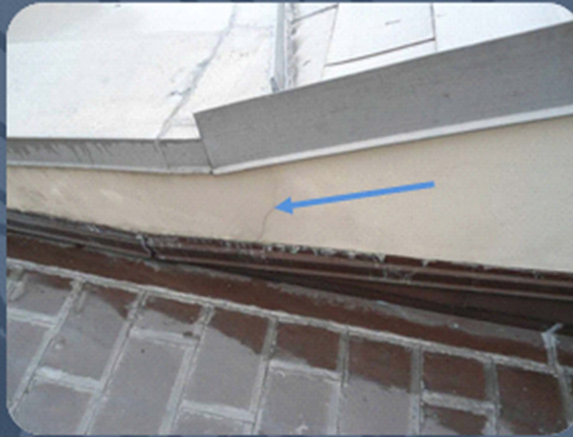
- Observation
  - A crack was noted on the south-west side of the building in the exterior cornice. This crack was very small and did not indicate structural damage.
- Repair
  - K&H recommended patching in kind of the Keim coating in order to close the crack.

Figure 7. Cracks in exterior cornice.

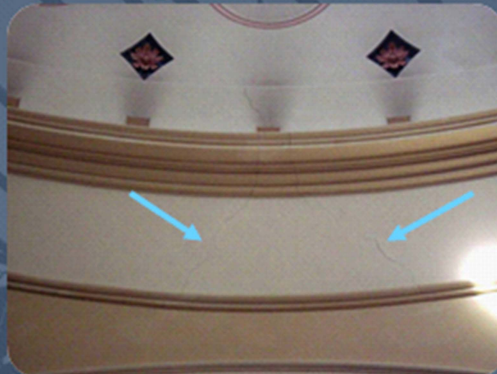
- Observation
  - Many cracks were observed in the plaster ceiling of the church. These cracks were mainly located at the keystones of the arches. Preexisting cracks displayed signs of exacerbation in terms of width and extent as result of the earthquake.
- Repair
  - K&H recommended the cracks should be chased out with removal of the plaster for observation of the structural backup. Cracks in the masonry structure were recommended to be injected with a low-viscosity cementitious mortar (Jan M30 #31 or M40, depending on the crack width, or equivalent). Cracks beyond  $\frac{1}{8}$ " were recommended to be inspected by the engineer.

Figure 8. Cracks in plaster ceiling.

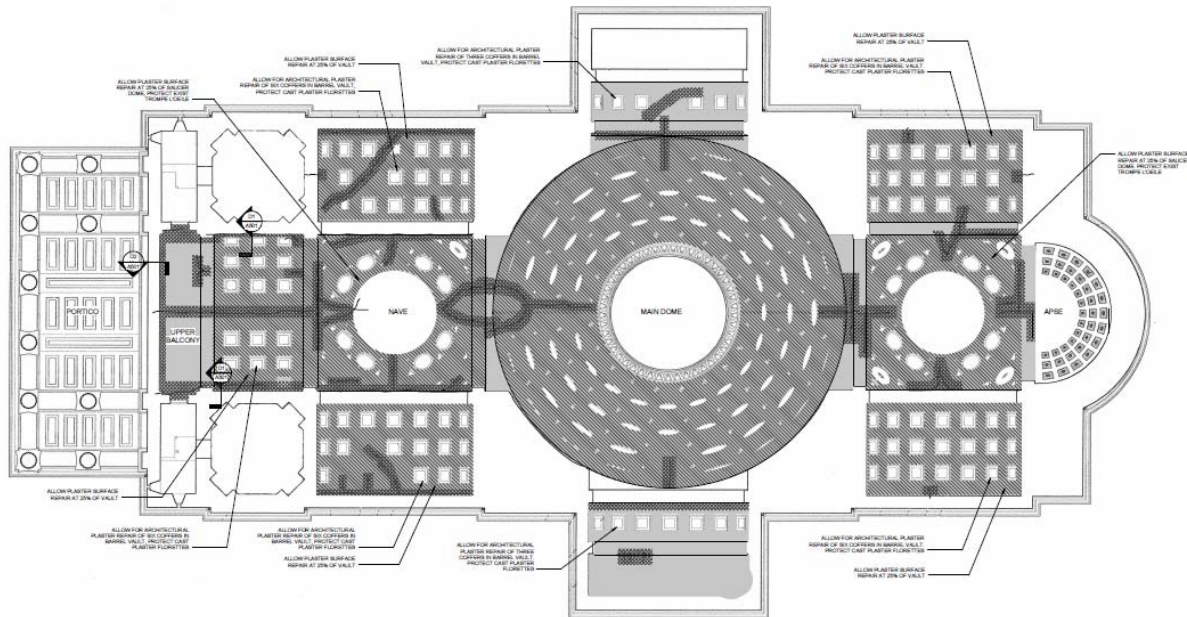
The recent 2006 renovation, which restored the Basilica's pristine architectural beauty, included extensive interior plaster, paint, and other non-structural restoration. In light of those recent aesthetic repairs and the limitation restricting additional probes, selective demo, and removal of finishes, K&H and the design team developed a map of structural repairs. Areas of visually apparent cracked plaster were assumed to be indicative of cracked masonry beyond. Construction pricing at these areas was developed to account for both plaster repair and typical masonry crack repairs (crack injection). Figure 9 pictures a reflected ceiling plan indicating areas of cracked masonry requiring repairs. Fig. 9 also illustrates the extent of potentially invasive repairs required throughout the Basilica.

Figure 9. Reflected Ceiling Plan - Plaster / Masonry Crack Repairs.

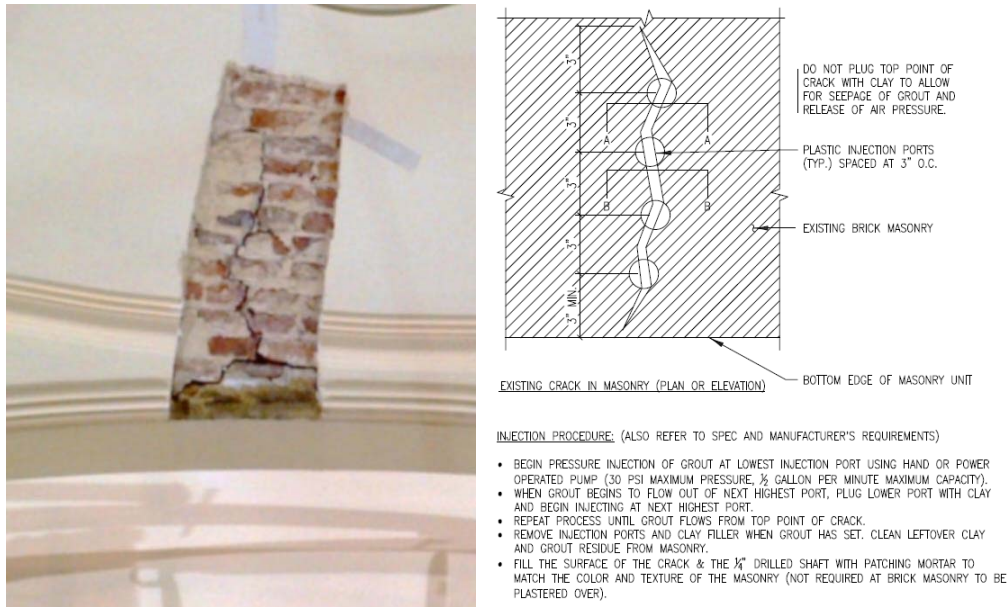
In order to reestablish the load bearing capacity of the brick masonry elements, crack injection of brick and stone masonry was conducted where appropriate. Fig. 12 highlights a crack injection application within the Basilica.

Figure 12. Masonry brick crack injection repair.

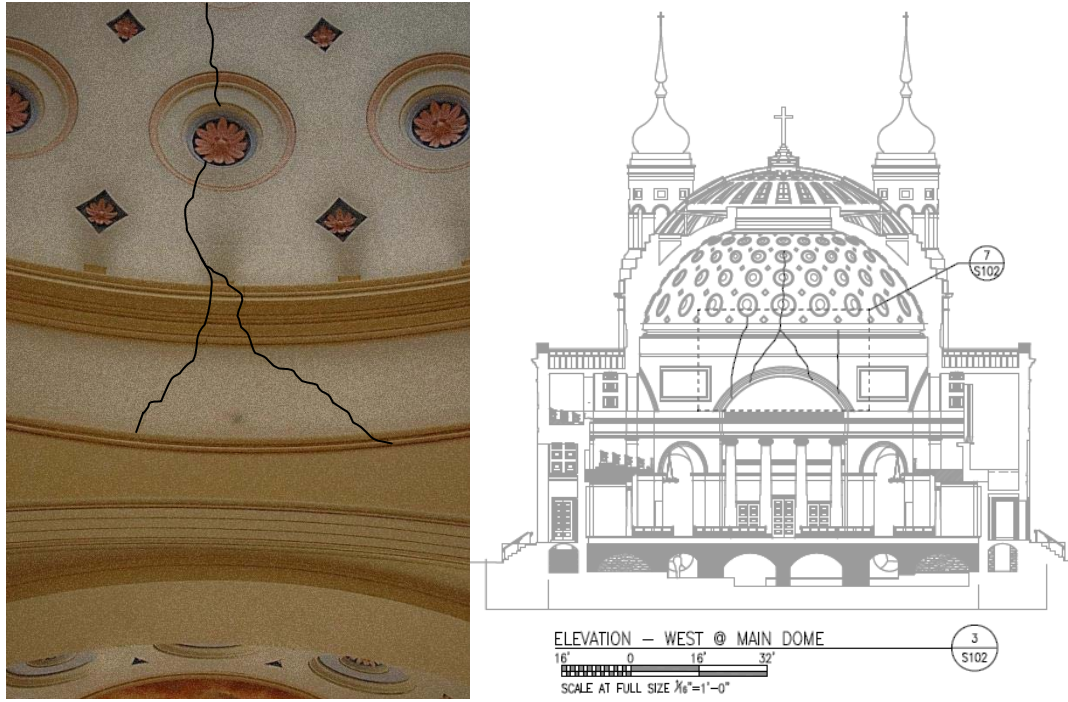
Key areas of distress were observed at the underside of brick arches. Fig. 13 shows typical cracking above brick masonry arches indicative of load reversal associated with seismic activities. Through additional investigation during the construction process, K&H observed this particular location to be a through-wall crack visible on the exterior of the building as indicated in Fig. 14. Due to the critical location at which the distress was observed, the keystone of the arch, repairs specified Cintec threaded anchors to cross-stitch the compression arch and reestablish the intended load path (Fig. 14). However, before installing the Cintec anchors, the wall was scanned in-field to locate an existing tension ring. No tension ring was located at the area indicated for repair and thus the Cintec anchors were installed without jeopardizing the integrity of the masonry dome. The Cintec anchor repair is depicted in Fig. 15 with construction installation pictured in Fig. 16.

Figure 13. Typical cracking above brick masonry arch.

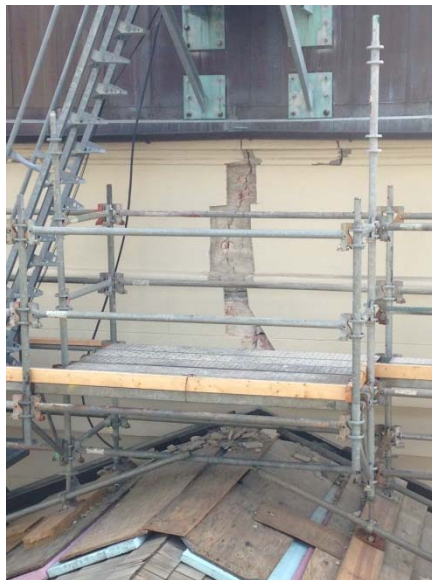
Figure 14. Exterior through-wall crack above brick masonry arch.

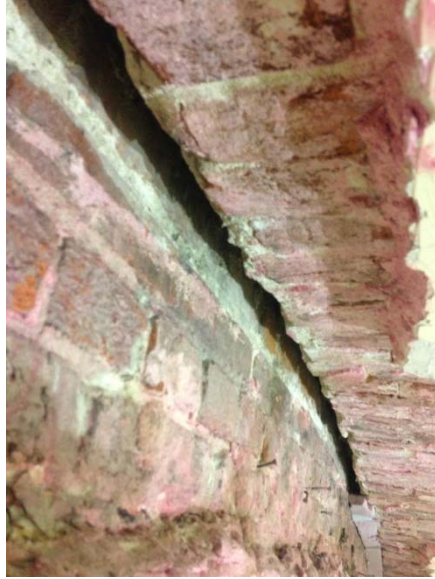
Distress was observed at the transition of brick domes to barrel vaults, a critical load path transition area (Fig. 17). As a result of the weakened compression capacity at these areas, Helifix “DryFix” anchors were applied to bridge the crack separation of the brick domes to the brick vaults. Helifix “DryFix” anchors were also applied at areas of exterior wall separation from interior brick vault structure. The repairs as designed in the field are pictured in Figs. 18 and 19.

Figure 17. Masonry separation at brick dome connections to barrel vaults.

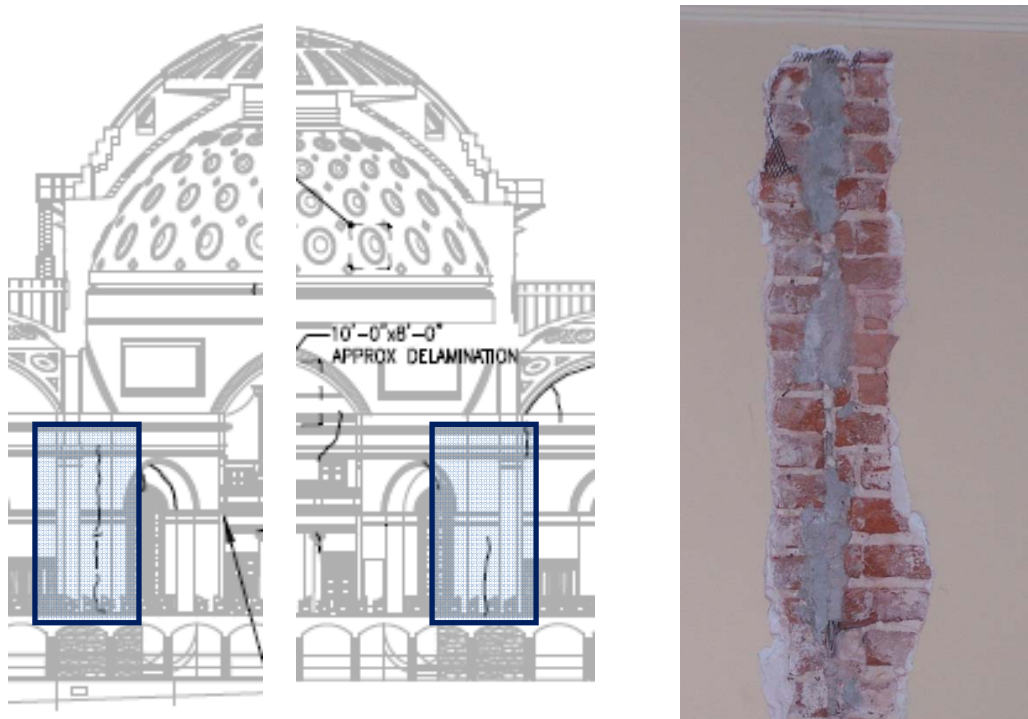
Vertical wall separation was observed at cold joints on either side of the main dome. Upon further investigation, a historical letter from Latrobe to Hayden, indicates the 8 main piers that support the dome had been incorrectly located during construction. As a result the dome was 8 inches longer in the north-south direction than the east-west direction. Latrobe promptly indicates this error as a botched legacy of the contractor [1]. The letter further states the construction error was fixed by reducing the dome size and by bringing “forward the piers both in front of the Niches & of the side Aisles” [1]. In other words, the vertical wall separation occurred at the cold joint of the main dome support piers. The cold joints themselves occur at the additional wythe of masonry added during construction to fix the contractor’s error. This separation is pictured in Fig. 20.

Figure 20. Vertical wall separation.

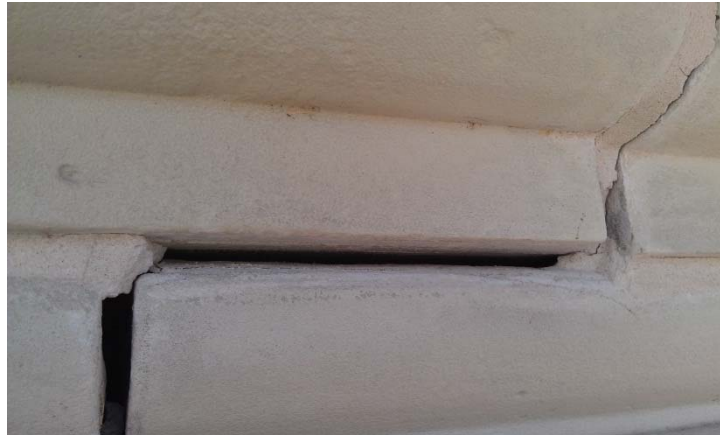
Figure 22. Exterior stone cornice separation.

Exterior stone cornice separation is pictured in Fig. 22. Repointing was required at all areas exhibiting similar distress.

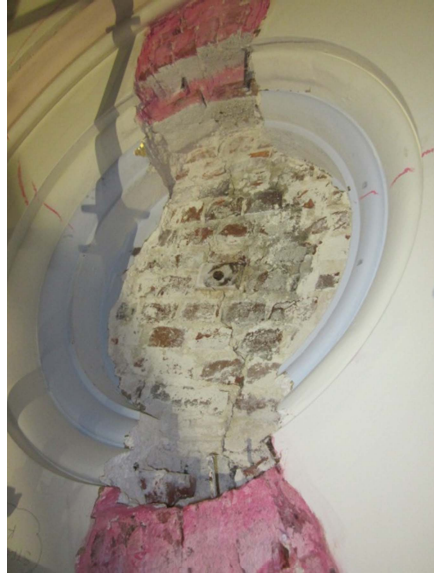
Figure 24. Cracking and plaster repair at main dome coffers.

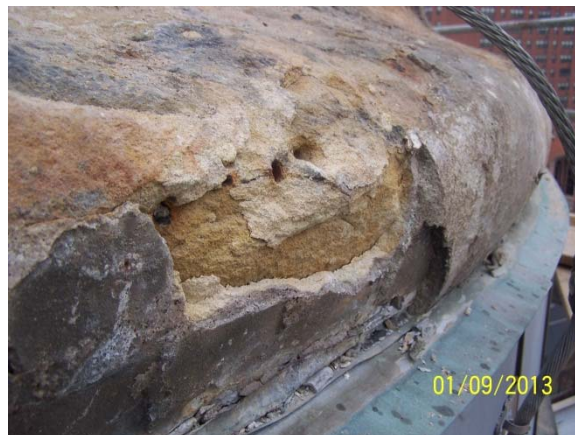
Figure 25. Exterior bell tower dome cementitious repairs distress.
