“THEN THE EARTH SHOOK AND TREMBLED...” THE WASHINGTON NATIONAL CATHEDRAL IN THE AFTERMATH OF MINERAL

Matthew C. Farmer¹ and Cortney L. Fried²

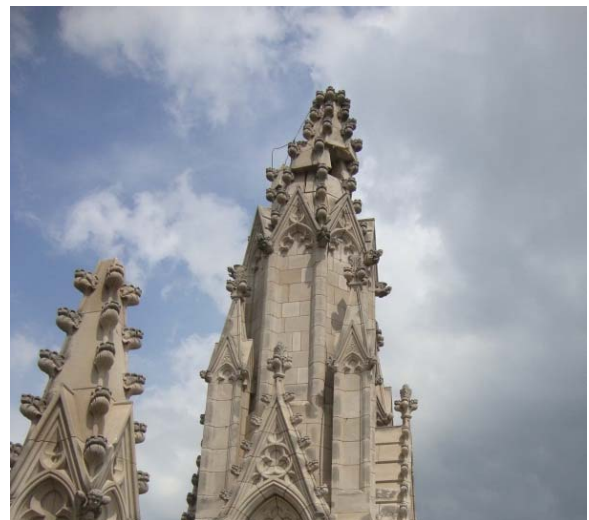
Figure 3. Damage at Grand Pinnacle.

Temporary overhead protection and debris netting were positioned over entrances in anticipation of reopening the Cathedral prior to completion of repairs. As a result of the significant damage to the Central Tower grand pinnacles (see Figure 3), debris netting and scaffolding were installed to create a semi-permanent working platform, enabling the partial dismantling of the grand pinnacles to remove unstable elements, and provide overhead protection in case additional pinnacle components become unstable prior to restoration

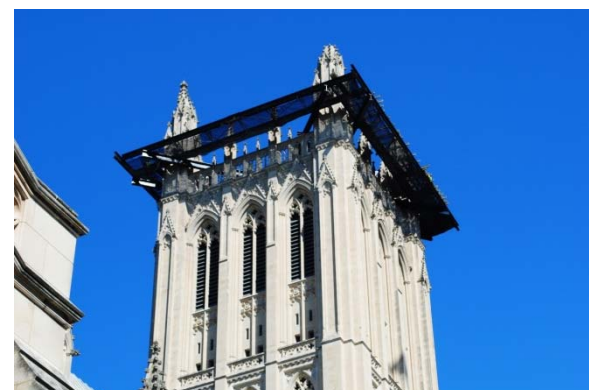
Figure 4. Platform and temporary protection at the Central Tower.

(see Figure 4). Scaffolding was also erected around the turret at the southwest corner of the South Transept to enable dismantling of the upper portion

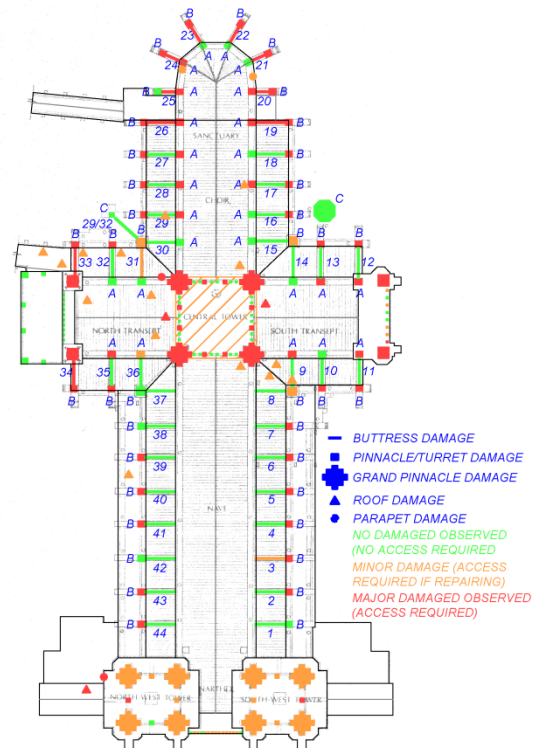
Damage to the exterior of the Cathedral resulting from the earthquake is widespread. The majority of the damage observed during our survey is at non-structural and largely ornamental, but very heavy, sections of limestone. The damage ranged from a loss of entire courses of limestone from the grand pinnacles at the Central Tower to minor spalling and chipping at joints between stone masonry units. The damage documented following the earthquake, was sorted into three categories based on the severity of the damage and the extent of in-situ stabilization, repair, removal, or reconstruction that will be required. The first category is “No Damage” (shown in green) and illustrates areas where no visible damage was observed and that will not require any scaffolding or similar means of access for repair. The second category is “Minor Damage” (shown in orange), which consists of limestone elements that contain visible damage at the exposed surfaces of the stone but remain materially intact and fully engaged to the structure. Repair of these elements, which in several locations include surfaces and features that do not contribute significantly to the architecture of the Cathedral, can be undertaken on a more voluntary basis as funding becomes available. The final category is “Major Damage” (shown in red) and includes: missing or otherwise visibly unstable elements that remain a potential fall-hazard, and damage considered structurally insignificant but in need of immediate repair to restore the originally intended architectural expression of the element. Areas identified as “Major Damage” will require pipe-scaffolding and/or the use of mobile cranes that can facilitate the removal, replacement, and resetting of large stone pieces. The exterior damage is graphically displayed Figure 5.

Figure 5. Summary of stone damage.

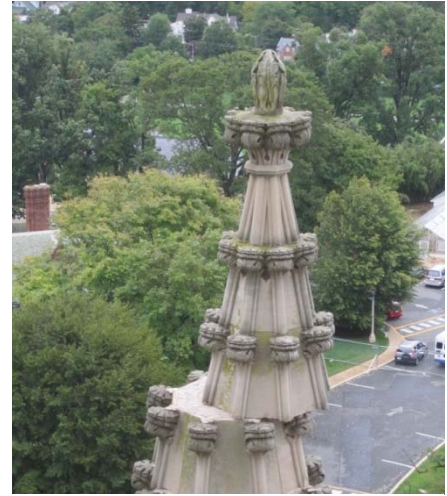
The pinnacles (grand, intermediate, tertiary) throughout the Cathedral structure vary in size and detailing; however, they all are typically tall and slender. Some are present at the lower elevations such as those atop the buttress piers; others are present atop the towers and occupy the highest portion of the Cathedral structure. Pinnacles are present at nearly every elevation of the structure. Construction of the pinnacles spanned from 1915 (Apse flying buttresses pinnacles) to 1990 (West Tower grand pinnacles). The earlier period pinnacles do not include any doweling between masonry elements while those built more recently incorporate bronze dowels and cramp anchors between stone masonry elements. The damage to the pinnacles consists of rotated finials, missing or damaged ornament, cracked or displaced stones, and displaced portions of the pinnacles (see Figures 6 and 7).

Figure 6. Displaced pinnacle.

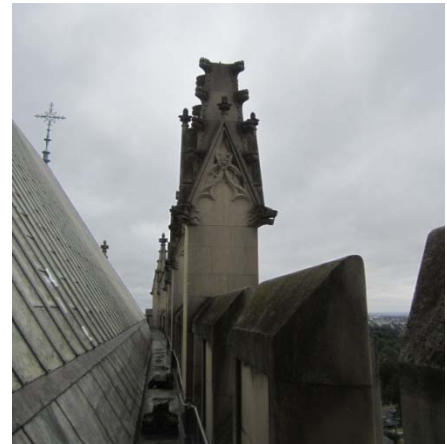
Figure 7. Broken pinnacle.

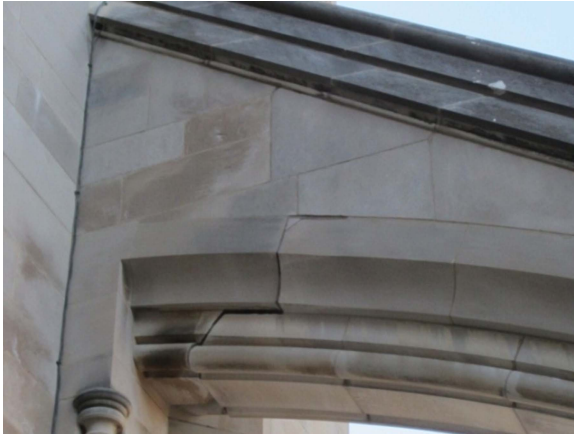
The primary damage observed included separations between the Apse buttress piers and the fliers, as well as distress within the flier masonry (see Figure 8 and 9); however, it is believed that this damage was largely the result of buttress pier settlement that predated the earthquake.

Figure 8. Damage at Apse buttress flier near Apse wall.

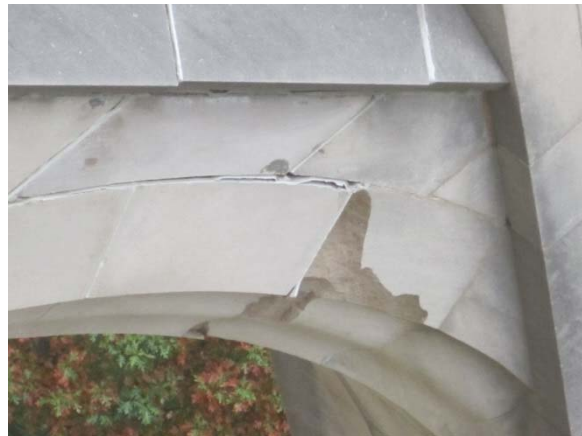
Figure 9. Damage at Apse buttress flier near pier.

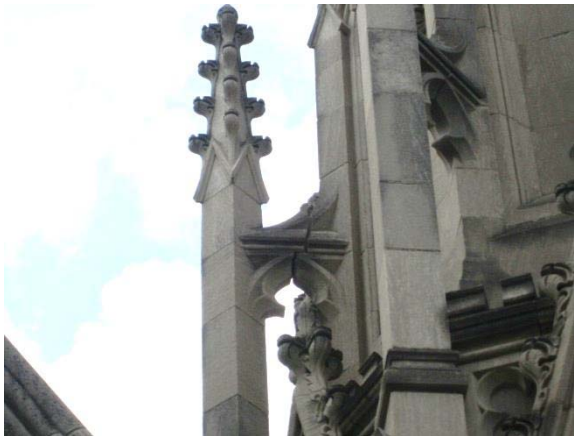
Figure 10. Broken tertiary pinnacle.

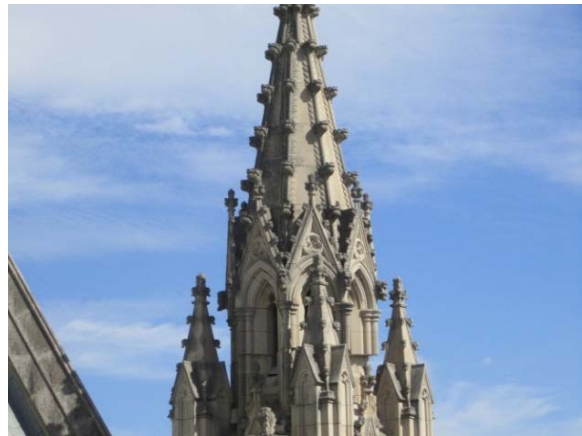
The turrets at the South Transept are unique in that the major pinnacle is supported on an open colonnade just above the Transept roof line. The entire pinnacle shifted laterally at the colonnade that served as a “soft story” (see Figures 10). The north transept turrets do not have the open colonnade but do incorporate slender tertiary pinnacles that are supported by small “fliers” that fractured as a result of the earthquake (see Figure 11).

Figure 11. Damage at colonnade of South Transept turret.

of unstable stonework by Cathedral Mason staff. The lower colonnade portion of the turret was unstable but not accessible without completely dismantling the turret. Shoring was installed within the colonnade to provide increased stability until more permanent repairs are performed.

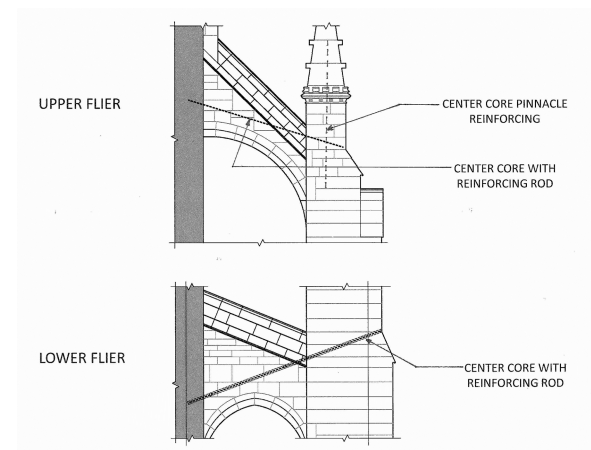
Figure 12. Apse flier strengthening.

As expected, out-of-plane response of the buttresses governed, with limited restraint for out-of-plane movement provided by the fliers. Deflections of approximately 1-1/2 inches were expected at the upper flier/pier interface. Considering the presence of the existing settlement damage, the buttresses, reinforcement of the flier/wall and flier/pier interface was desirable to re-establish a connection between elements and limit the potential for catastrophic collapse of the fliers, but not restrain the pier from displacing (see Figure 12).

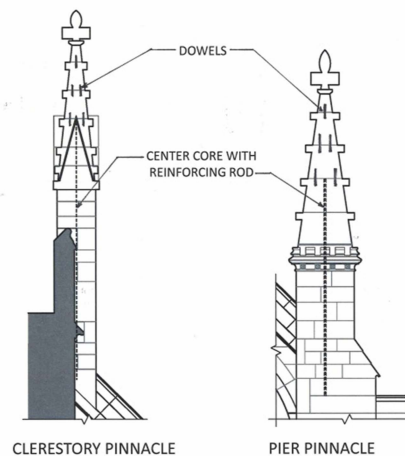
Figure 13. Apse pinnacle strengthening.

Damage at the Apse pinnacles consisted primarily of chipping and spalling at component perimeters in combination with rotation and/or displacement, attributed to rocking and tipping of the upper courses. The majority of damage occurred at the boundary between the second and third courses below the finial, with one location at a clerestory pinnacle shaft nine courses below the finial.

It was found that the accelerations required to cause damage at a given course did not vary greatly along the height of the pinnacles, suggesting that damage was as likely at the finials as the base of the pinnacles, with actual locations of damage dependent on the localized conditions of limestone and mortar at a given course. Therefore, since strengthening one or two or three of the top courses would result in increasing the hazard by increasing the weight of the element that would then be vulnerable, the strengthening concepts were extended throughout the upper portions of the pinnacles (see Figure 13).
