# A CASE STUDY OF POST-EARTHQUAKE STRUCTURAL ENGINEERING – THE BALTIMORE BASILICA

Matthew J. Daw<sup>1</sup> and C.Swift<sup>2</sup>

The response, assessment, and recovery effort as undertaken by Keast & Hood Co. for the Archdiocese of Baltimore provides a case study for post-disaster preservation of historic structures including immediate response, temporary stabilization, and post-response repairs with visually subtle, yet structurally sound, restoration detailing.

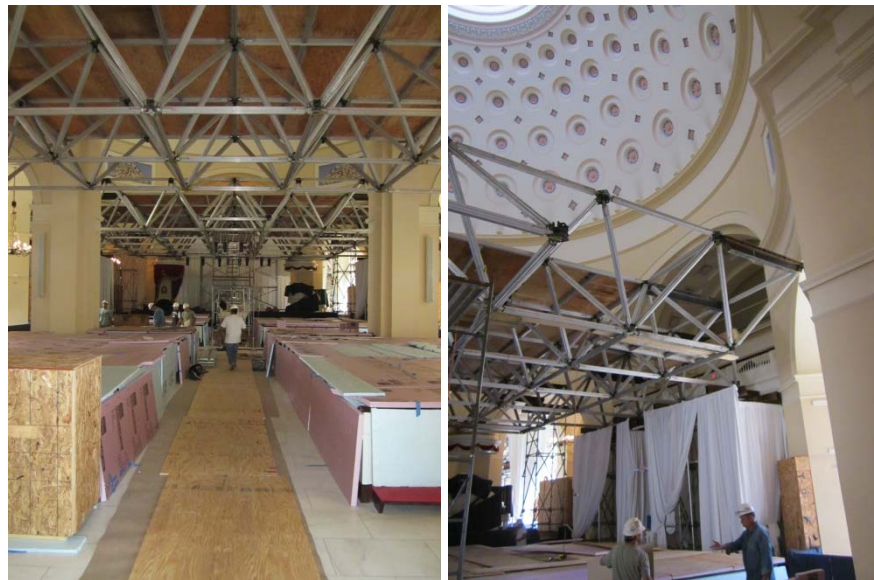
Truss scaffolding was erected to provide work access to the domed ceiling and areas of cracked plaster while bridging the pews and worship spaces below.

Figure 10. Truss scaffolding erection over pews and main worship space.

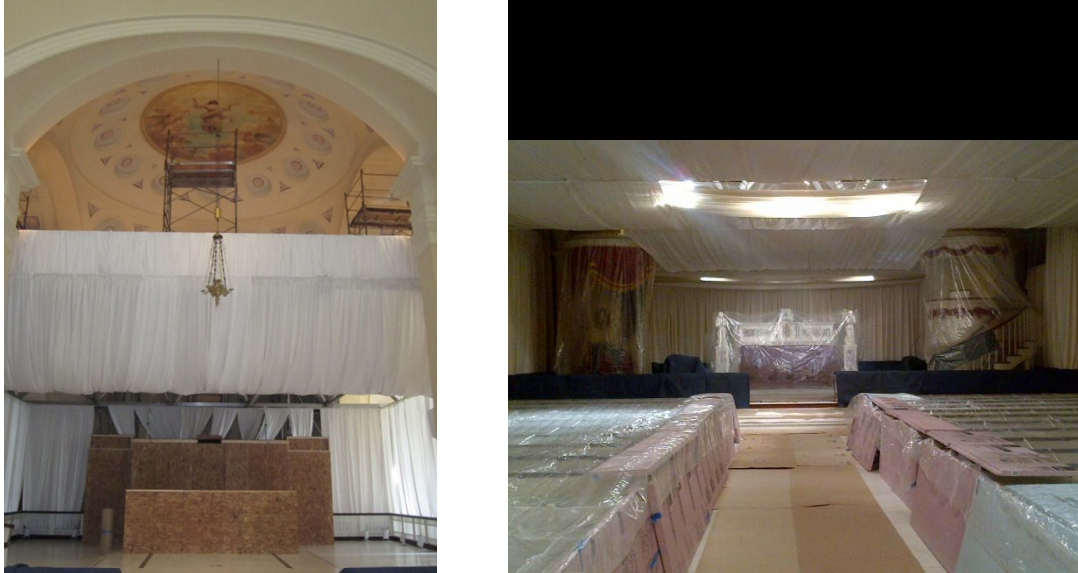
Figure 11. Finished truss draping and protection during construction.
