Tenth U.S. National Conference on Earthquake Engineering
Frontiers of Earthquake Engineering
July 21-25, 2014
Anchorage, Alaska

A STRUCTURAL HEALTH MONITORING SYSTEM FOR A DAMAGED CLASSROOM BUILDING DISPLAYED IN THE 921 EARTHQUAKE MUSEUM OF TAIWAN

J. F. Wang¹ and C. C. Lin²

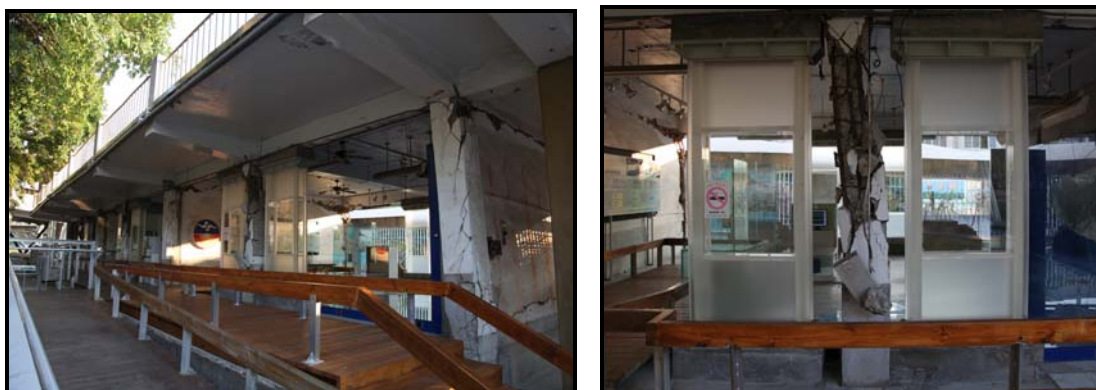
Figure 1. The Damaged South Classroom in 921 Earthquake Museum of Taiwan (Left: View from northwest; Right: AW retrofit)

The original DSC building is located at the footwall of the Chelungpu fault and only meters distant from the fault line. It received serious column damage along the corridor (x-direction) during the 1999 Chi-Chi Earthquake. The exhibition structure is a one-story building with $35\text{m} \times 11\text{m}$ base plan. In design, the exhibition structure is demanded to be capable of resisting gravity and earthquake loadings. Besides, the newly added components were demanded not to affect the display of the original damage appearance. Therefore, fourteen acrylic-glass walls were installed beside the damaged columns as the vertical and horizontal resisting elements, as shown in Fig. 1.

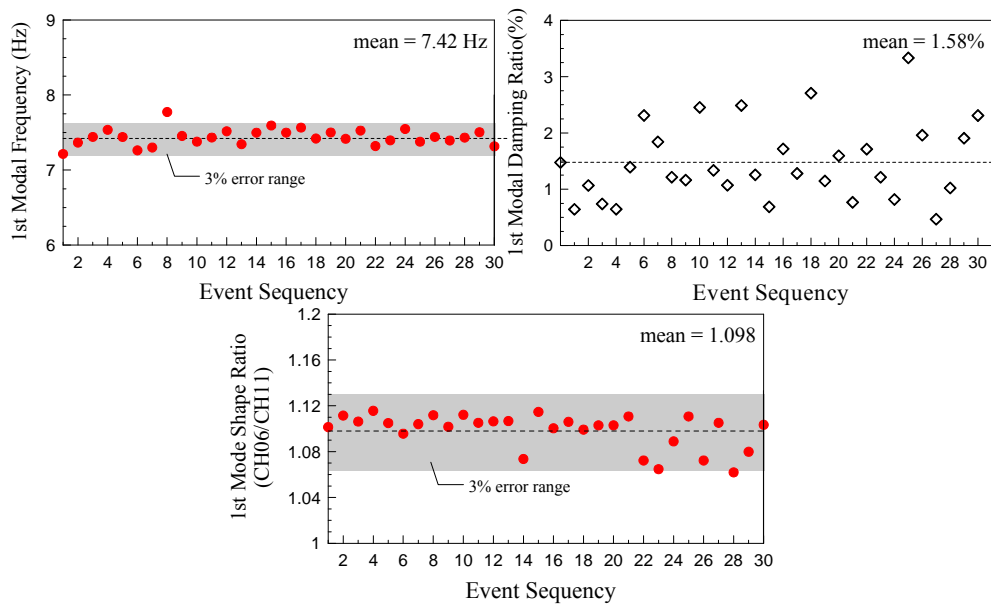
Figure 6. Optimum identified results of 1st modal frequency, 1st modal damping ratio, and 1st mode shape ratio (CH6/CH11) via the proposed criterion

Fig. 6 shows the optimum set of the first modal frequency, modal damping ratio, and mode shape ratio (CH6 component/CH11 component) from the 30 earthquake events. It can be shown that the variation of the first modal frequency is limited to 3% of the mean value, 7.42Hz, except that of the 8th event. In addition, the mode shape ratio is also limited to $\pm 3\%$ of 1.098. The variation of damping ratio is larger than the others, which means it is not suitable to be a baseline of the DSC building.
