Tenth U.S. National Conference on Earthquake Engineering
Frontiers of Earthquake Engineering
July 21-25, 2014
Anchorage, Alaska

MEASURES DEVELOPED IN JAPAN AFTER THE 1964 NIIGATA EARTHQUAKE TO COUNTER THE LIQUEFACTION OF SOIL

S. Yasuda¹ and K. Harada²

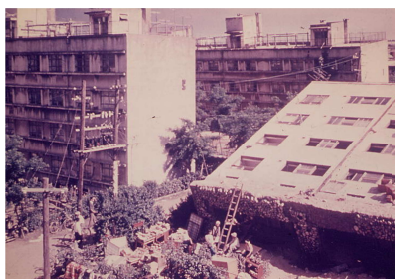
Figure 2. Settled apartments at Kawagishi Town (Photo by Watanabe)

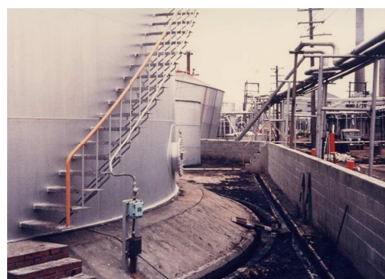
Figure 3. Settled and tilted oil tanks (Photo by Watanabe)

had been constructed. Among them, 340 reinforced concrete buildings were damaged by liquefaction during the 1964 earthquake. About half of the damaged buildings settled and tilted without cracks forming in their walls. Oil tanks settled and tilted, as shown in Figure 3. The Showa Bridge, which crosses the Shinano River, collapsed, as shown in Figure 4. According to several witnesses, the bridge girders started to fall about one minute after the main shock. Detailed soil investigations and the observation of a damaged pile were carried out after the earthquake and clarified that the liquefaction depth was about 10m and the pile was bent at almost the same depth as that of the liquefied soil. It was estimated that the piles deformed substantially in the horizontal direction during small shaking after the main shock because the bearing capacity of the surrounding ground had decreased drastically due to liquefaction (Yoshida et al., 2007). Buried pipes, a manhole and tanks were also damaged. An uplifted sewage tank is shown in Figure 5.

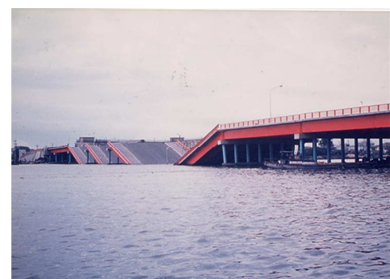
Figure 4. Collapsed Showa Bridge (Photo by Watanabe)

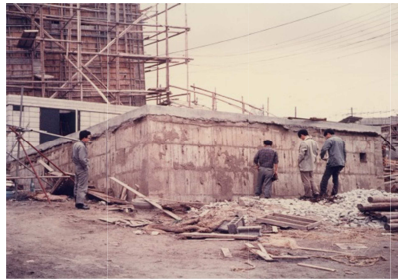
Figure 5. Uplifted sewage tanks (Photo by Watanabe)

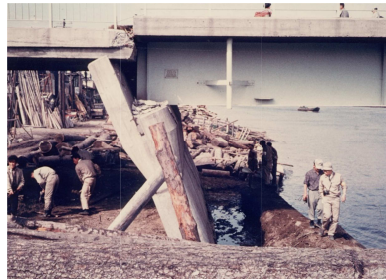
Figure 6. Tilted abutment of Yachiyo Bridge (Photo by Watanabe)

Moreover, extensive ground flow occurred, aggravating the damage. The distribution of ground displacement due to ground flow was measured 22 years after the earthquake from aerial photo surveys made before and after the earthquake (Hamada et al., 1986). This study confirmed that extremely large ground displacements, of up to 8 m, occurred along the Shinano River, as shown in Figure 1. The river's banks had been protected mainly by sheet piles. The ground behind the sheet piles flowed towards the river, pushing the piles towards the centre of the river. Many piles collapsed onto the river bottom. The maximum distance of ground flow from the river was about 300 m. Many structures, such as road bridges, a railway bridge, buried pipes and buildings, were severely damaged by the ground flow, as shown in Figures 6 and 7.

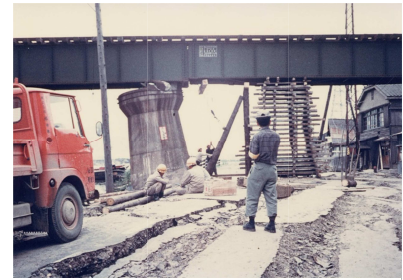
Figure 7. Tilted pier of Shinanogawa Bridge (Photo by Watanabe)

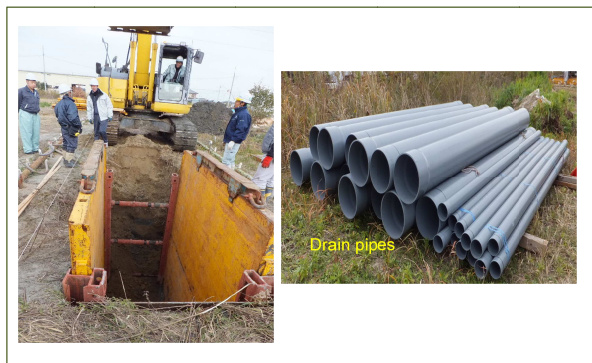
Figure 15. In-situ test to demonstrate the effect of drain pipes in Kamisu City

The applicability of these methods is being studied by in-situ tests, centrifuge tests and analyses. Figure 15 shows in-situ test conducted in 2013 in Kamisu City for lowering the ground water table to about GL-3m by placing drain pipes. Two rows of drain pipes with a distance of 46 m were placed at a depth of GL-3.5 m in the excavated and filled trenches. Test results showed that the ground water table could be lowered to the depth of about GL-3 m in the area surrounded by the drain pipes. And the ground settlement due to the consolidation of alluvial clay layer was very small, less than 1 cm. It was decided by Kamisu City Government to treat an area of about 1 km by 1 km in the Horiwari and Wanigawa districts by this method. Figure 16 shows the layout and cross section of drain pipes. The construction of the drain pipes will start in June 2014. In Tokai Village, the construction of drain pipes to lower the water level was started in 2013. Similar constructions will start soon in several other cities.
